The
Building
Conservation
Directory

HISTORIC

CHURCHES

THE CONSERVATION AND REPAIR OF ECCLESIASTICAL BUILDINGS

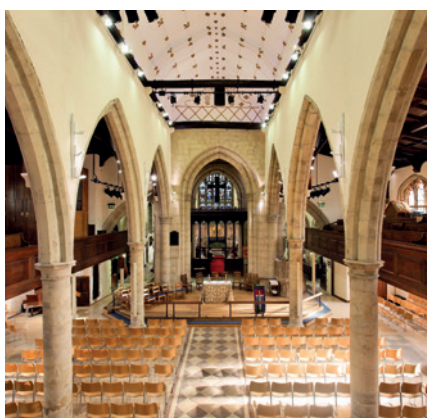
St Mary the Virgin, Ashford, Kent: reordering for community centre with removal of pews (Photo: Lee Evans Partnership)

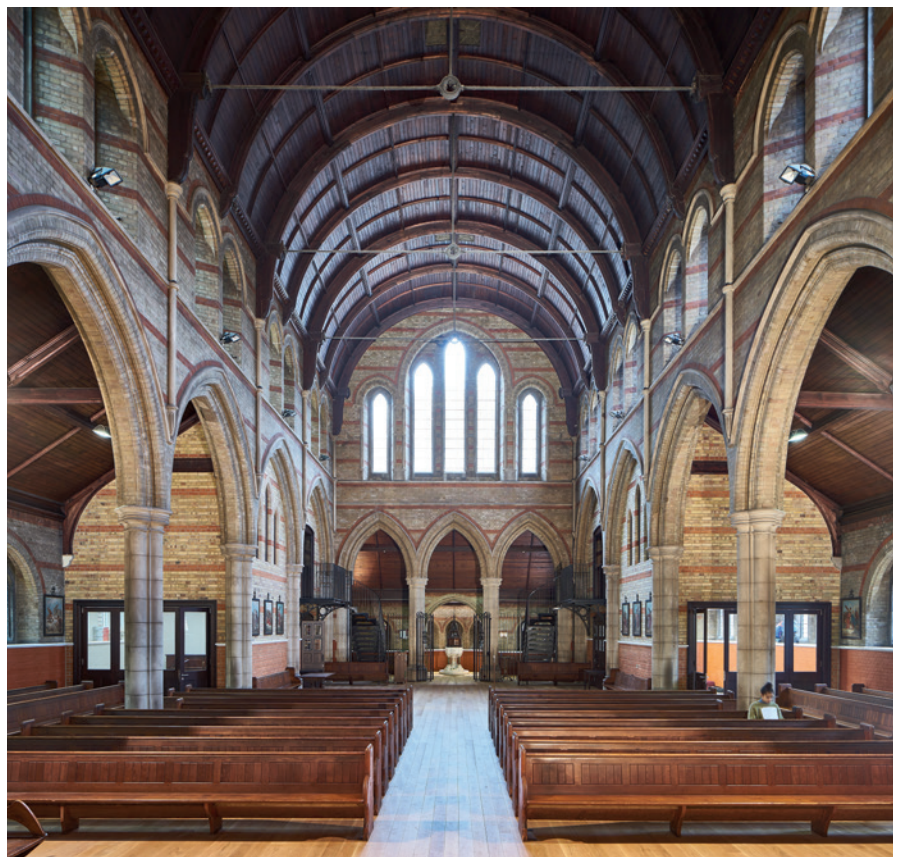
The nave and narthex of Emmanuel Church, West Hampstead, with completed community rooms to either aisle and simple railings (Photo: Thomas Erskine)

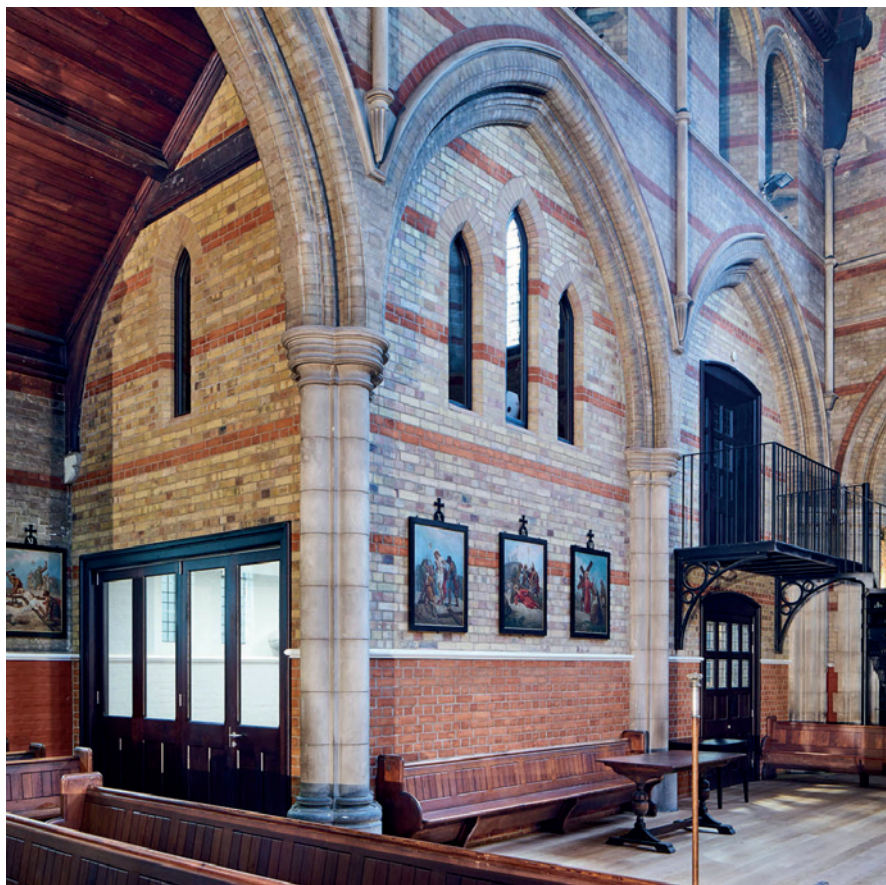
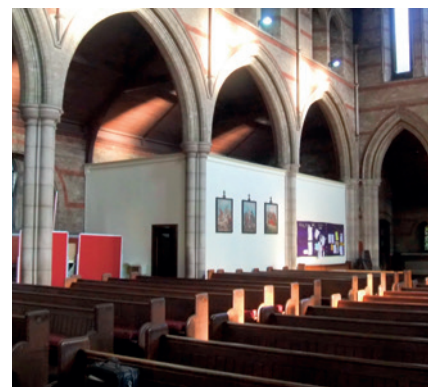
The former single storey meeting room to south aisle, built in 1968 (above) and the new brick-walled community rooms which replaced it (left)

In 1968, a meeting room with a flat roof was installed in the south aisle and around the same time half of the pews were removed and a WC and a small kitchen area were installed in the south west entrance porch. By the end of the century, demand for community

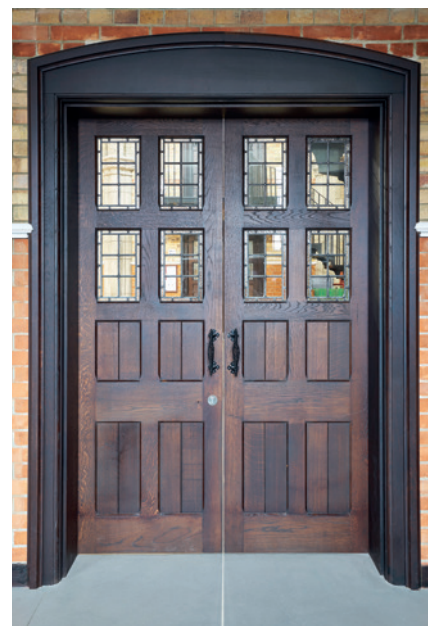
One of the new community room doors with traditional leadwork and bespoke ironmongery (Photo: Thomas Erskine)

that the new community rooms should be constructed in brickwork to match the surrounding walls, rather than in painted plasterboard like the 1968 meeting room walls. Although a lightweight timber frame and plasterboard may seem the more reversible of the two options, steel beams would have been needed to support the upper community room floor structure. By progressing the design further with structural input from Stand Consulting Engineers, it was agreed that the proposed brick masonry infills would be a more 'honest' intervention, and would form a more permanent part of the building's story as a place which evolves to meet the needs of the parish.

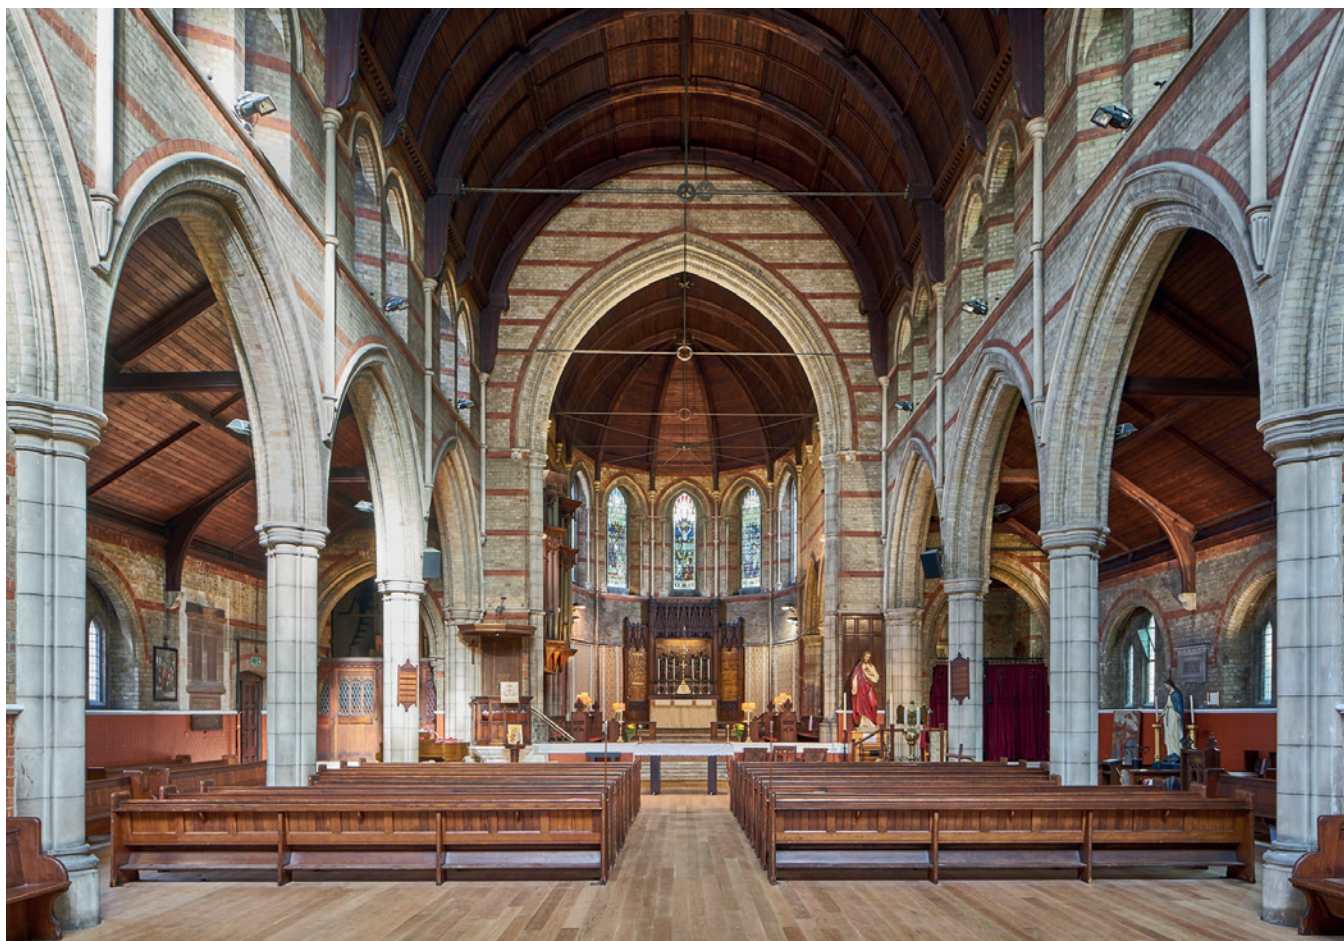
The nave and chancel of Emmanuel Church, West Hampstead with its new oak floor (Photo: Thomas Erskine)

of the floor in the main body of the church. By the time the project restarted, parts of the parquet floor had become so buckled that level changes of around 100mm were evident in various parts of the church, causing trip hazards and limiting their use.

Given the history of structural movement caused by the soft clay on which the church is built, Stuart Tappin of Stand Consulting Engineers arranged soil investigations in early 2010 and provided structural advice for proposals to rectify the uneven floor. The conclusion was that the best solution was to remove the existing floor slab completely throughout the nave, aisles and narthex, and to replace it with a new slab supported on 30 piles over

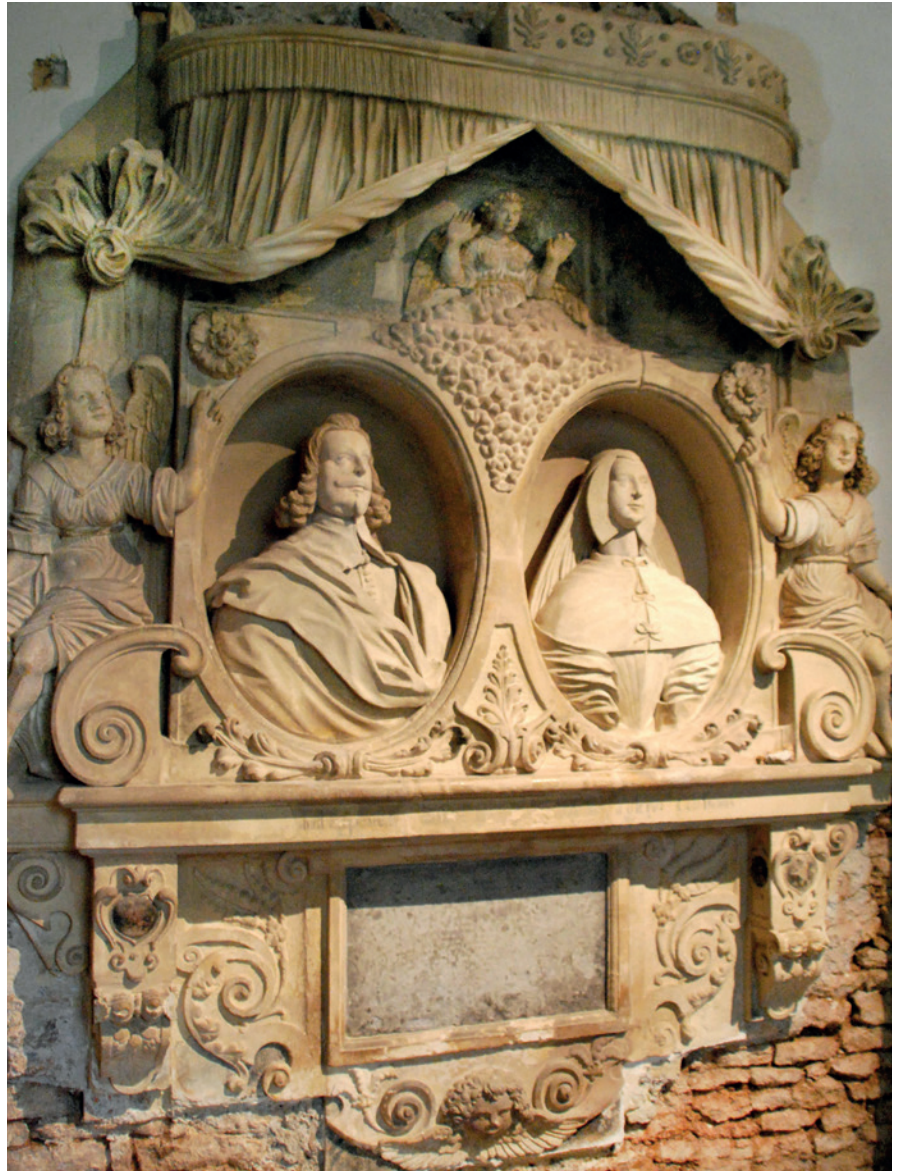
The monument to Sir Edward and Lady Francis Rodney on the west wall of the Rodney Chapel, St Leonard's Church, Rodney Stoke, Somerset: investigation windows were opened up above the monument (top left and right) to ensure there was no evidence of early plaster and decorative schemes, and the hard plaster was removed at lower levels.

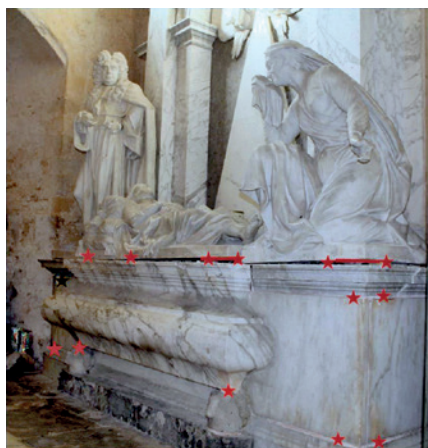
The monument to the Hon Robert Dormer (d1726), Church of the Holy Cross, Quainton, Buckinghamshire, showing the location of the iron fixings and the significant movement through the joints caused by the corroding iron fixings

Typically, the cause of structural movement is the deterioration of the system of iron fixings used to construct the monument. Iron is susceptible to corrosion in the presence of moisture and air. This causes the fixings to expand, exerting pressure on the sections of stone and often resulting in dramatic movement through the joints, cracking and buckling. Rust 'jacking' has the power to lift substantial free-standing elements, destabilising them. An example of this can be seen on the monument to Robert Dormer (illustrated above left), which is attributed to the great Flemish-born sculptor John Michael Rysbrack. Here, two large sculptures have been lifted out of position through pressure exerted by the corroded iron fixings. Once the pointing mortar falls out, this type of deterioration accelerates due to the greater exposure of the iron to both moisture and air.

The critical factor which draws the attention of the PCC and architect to a church monument is usually evidence of movement through the joints, sections of the monument shifting out of alignment and associated iron-staining on the surface. At this stage a monument may pose a significant threat to public safety and demands investigation.

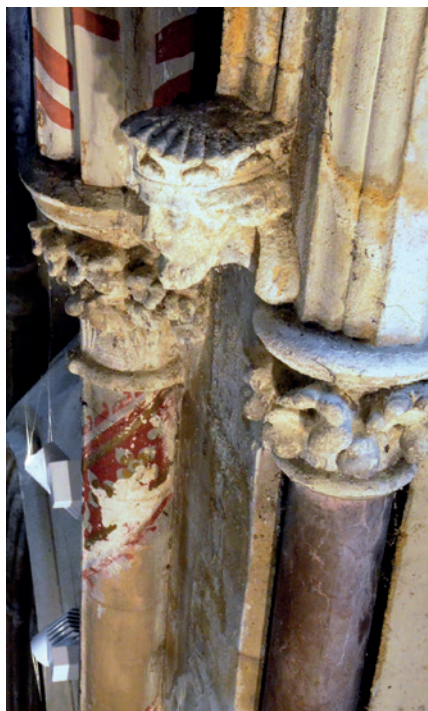
Salt crystallisation damage at a high level caused by warm, moist air condensing on cold fabric

Surface deterioration often indicates high levels of moisture in the building envelope and the internal environment. Historic fabric will always retain moisture and soluble salts and the management of salt activity is one of the biggest challenges in the treatment and care of church monuments. Cyclical changes in temperature and relative humidity in the microclimate can trigger an acceleration in the movement of soluble salts through porous material towards the surface, where they move out of solution and crystallise either on the surface (efflorescence) or just behind the surface (cryptoflorescence).

Some salts are hygroscopic and draw moisture in from the surrounding microclimate, causing them to dissolve and recrystallise in the pores of the material in increasing concentrations. The force of crystal growth, like rust expansion, can be substantial, breaking down the integrity of the pore structure and leading to blistering, spalling and loss

Deterioration of historic paint layers, biological growth and surface-staining of church monuments can be associated with the microclimate and repetitive cyclical changes in temperature and humidity. Condensation can form on surfaces which are colder than the general environment, contributing to ongoing salt activity, staining and deterioration of paint layers. The problem of spring condensation in churches – when warm, humid air enters the building and condenses on interior fabric – is well-documented.

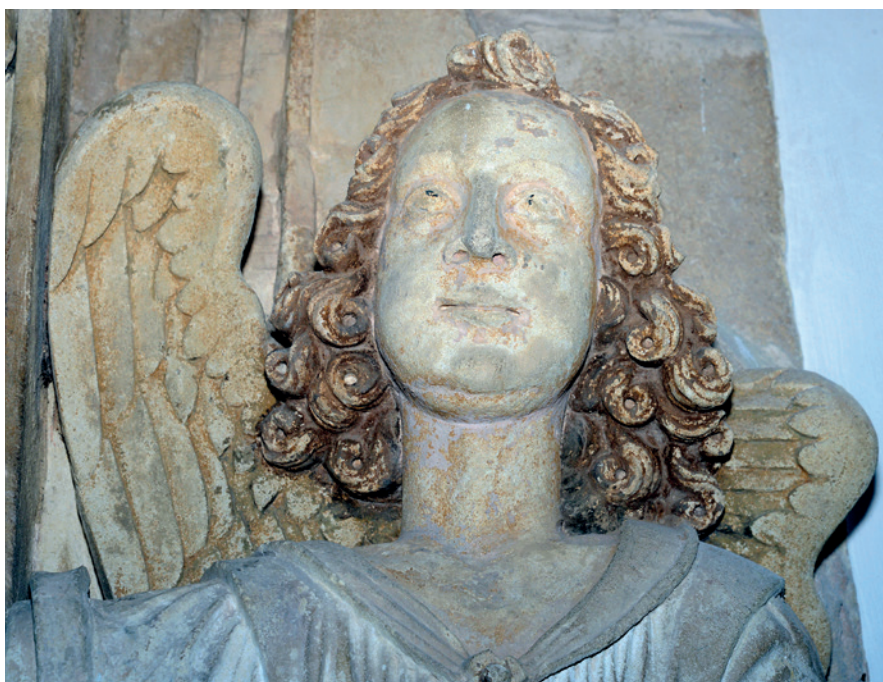
Detail of flanking figure to Sir Edward and Lady Francis Rodney monument showing pigment loss (Photo: Roger Vlitos)

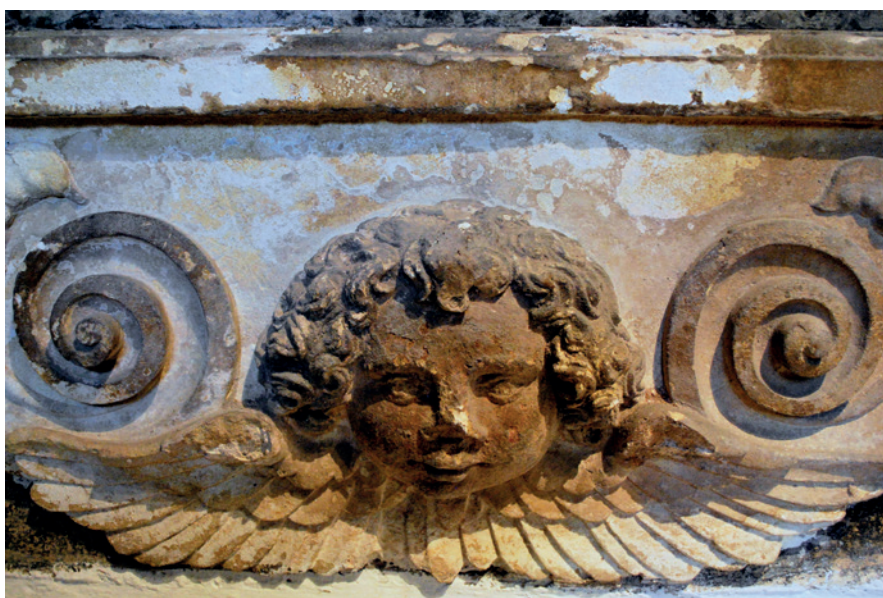
Detail of the lower section of the monument to Sir Edward and Lady Francis at St Leonard's showing salt efflorescence with associated blistering and loss of surface due to raised levels of moisture and salt activity

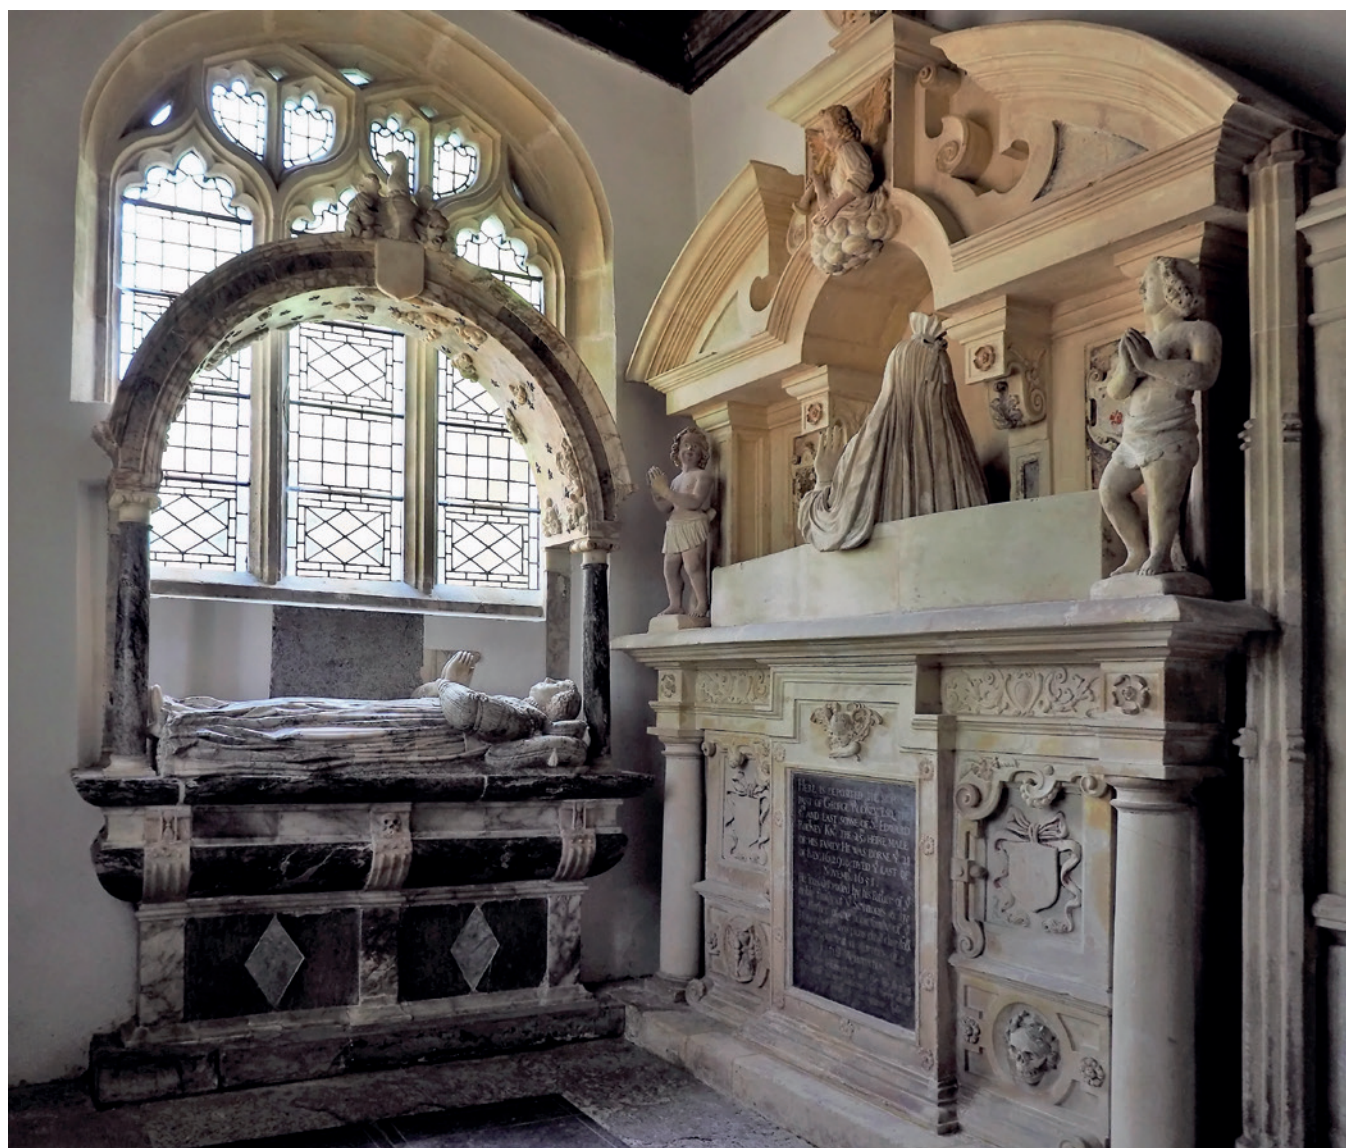
The south east corner of the Rodney Chapel after conservation showing the monuments to (right) Anne Lake (d1630) and Sir George Rodney (d1651)

chapel. Beginning in June 2016 moisture readings were taken twice a week from 30 locations in the chapel alongside a record of the weather conditions and rainfall. After the first few weeks it became apparent that excessive levels of moisture were being retained in the fabric of the Rodney Chapel including the internal walls and at high level. In some areas there was a delayed response in relation to the rainfall.

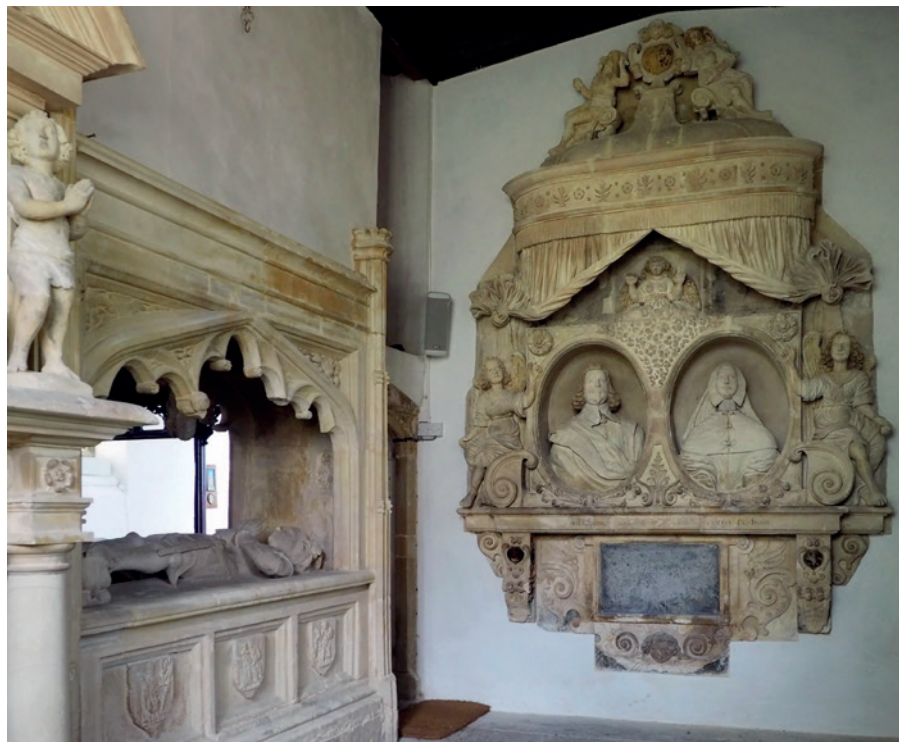
The monument to Sir Edward and Lady Francis after conservation and with the new lime plaster in place

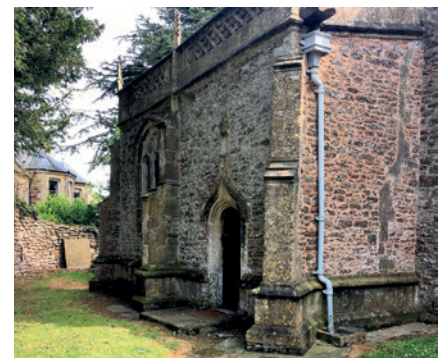
The north and west elevations of the Rodney Chapel showing the lime mortar pointing on the west elevation and the lowered ground level, now re-turfed and sloping away from the base of the stonework

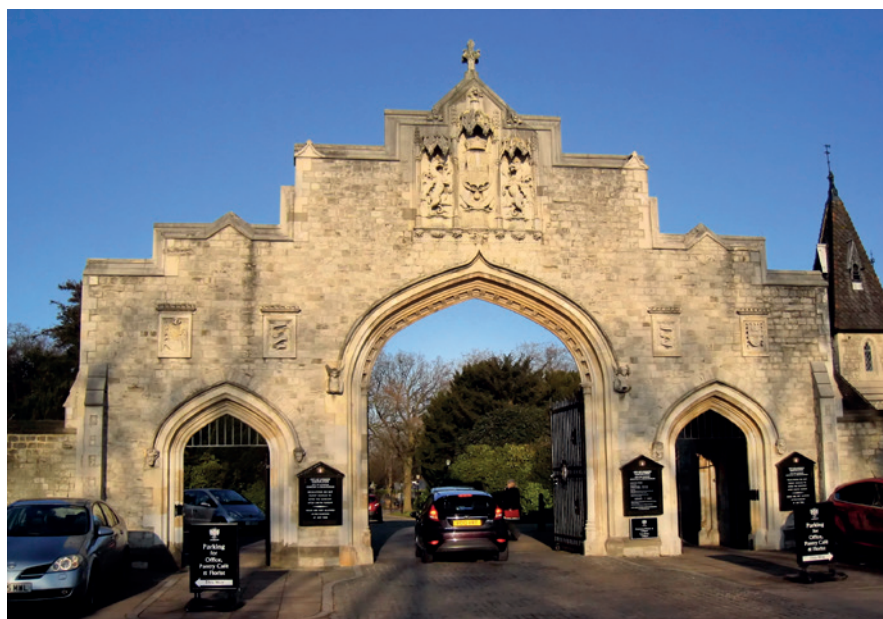
The City of London Cemetery screen before the project: the use of impermeable cement repairs had increased the rate of decay to the point that the stonework had become unsafe. The central shield in particular was perilously close to becoming detached.

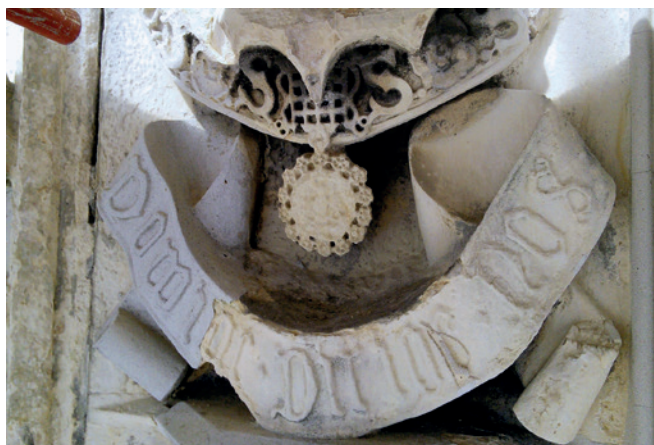
The bottom of the crest before work: note the cementitious repair (left) and adjacent erosion.

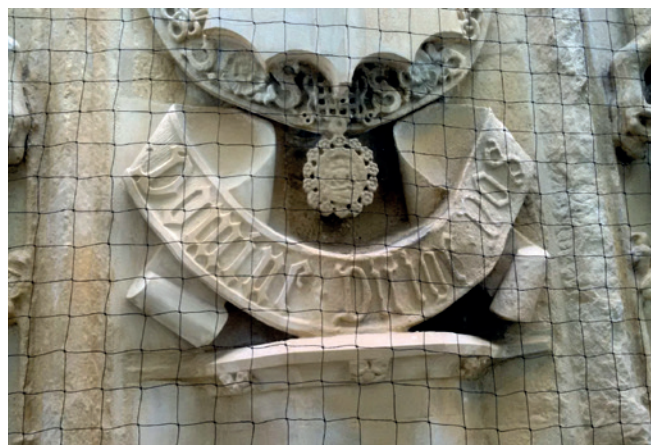
The bottom of the crest completed: note the retained original fine carved medallion and the new shield above it. The friable areas of stone were first consolidated with nanolime, then mortar repaired and limewashed.

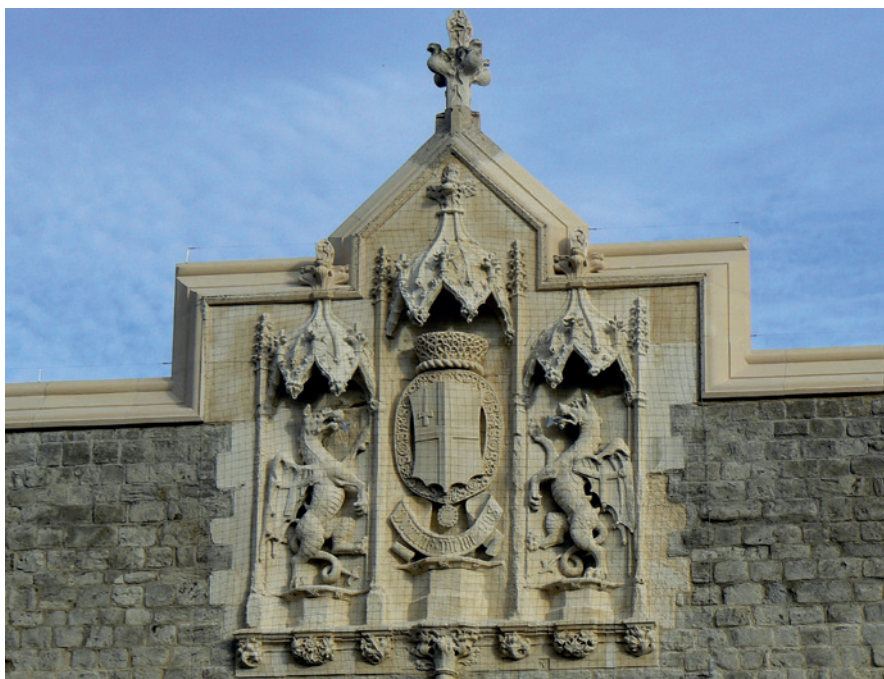
The central crest after consolidation and repair: note the new stone shield, Muscovy hat, copings and foliate corbels with nanolime consolidation and limewash.

A four-pronged approach was adopted to the repair of the central panel:

- 1 Cement repairs were selectively removed to slow down decay of the carved stone.
- 2 The entire surface was treated with a combination of Calosil E5 (which contains 5g nanolime per litre) and E25 (25g per litre), the rationale being that the E5 will give greater penetration to start with, followed by the E25 to deliver maximum amounts of lime to the structure. The Calosil was applied with a pressurised garden spray; five applications of E5 followed by three of E25 over a two-day period. The area was covered with cling-film between applications to prevent premature evaporation of the ethanol and so promote maximum penetration. It is important that water is sprayed onto the treated area for a period afterwards because the lime requires both air and water to carbonate.
- 3 Selected areas of previous mortar repairs were reinstated in a hybrid mortar to slow down further stone

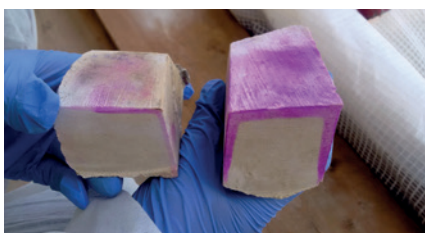
The depth of penetration of the nanolime was gauged with the use of phenolphthalein, which turns pink in the presence of un-carbonated lime. The sample of stone treated with the nanolime was cut in half and sprayed with the indicator: the depth of penetration is clearly seen.

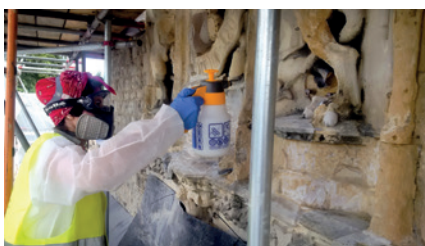
Nanolime was applied with a pressurised garden spray and the area was covered in cling-film between applications to delay evaporation of the ethanol and promote maximum penetration.

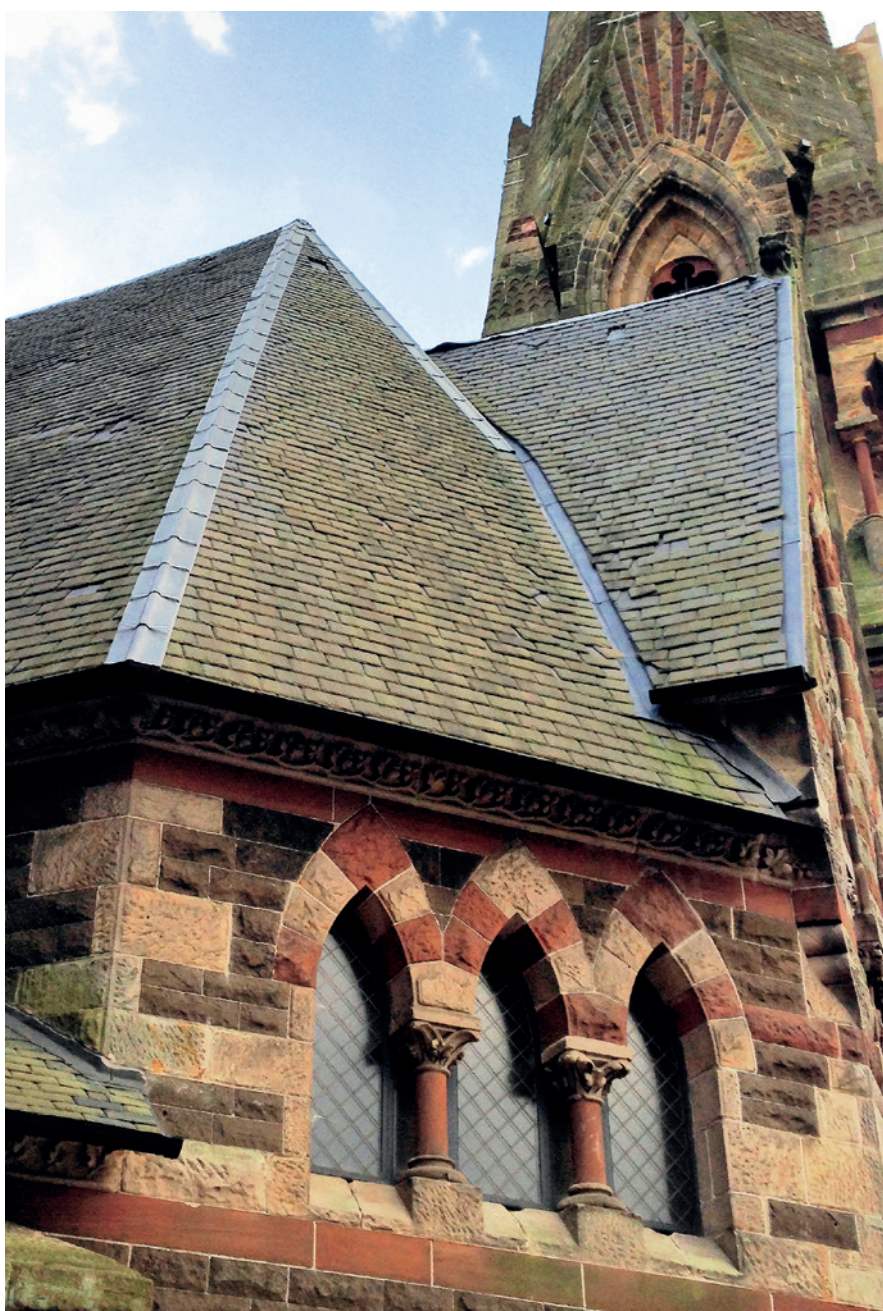
Storm damage to the roof of Trinity Church in Irvine, North Ayrshire due to poor slate fixings and the use of lightweight zinc ridges (All photos: Rebecca Cadie)

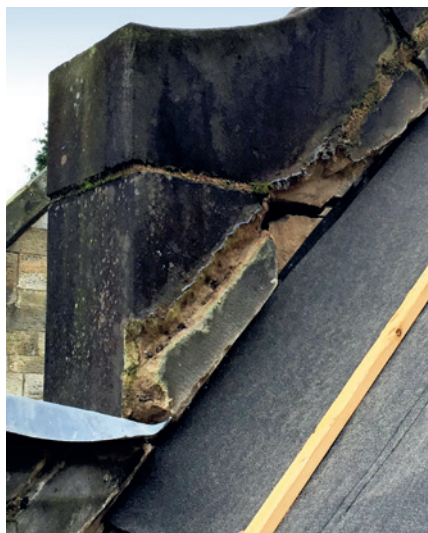
Erosion of skew masonry beneath defective flashings, with flush cope stones above

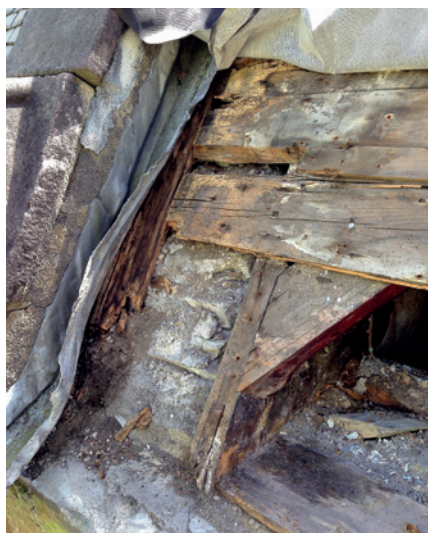
Rotten sarking caused by a failing skew abutment

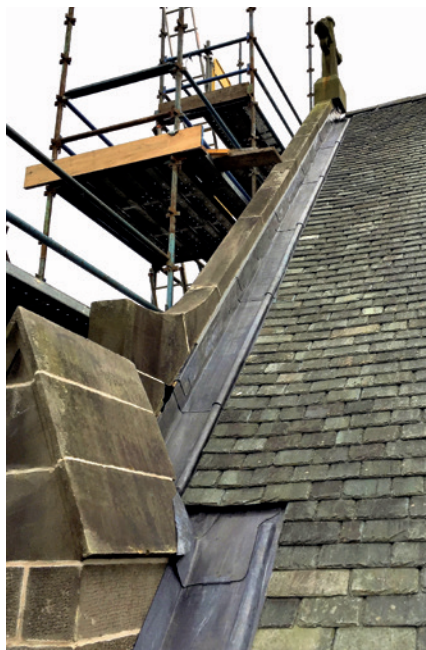
A new 'watergate' with a lead skew flashing and a storm roll to prevent storm water spreading into the sarking

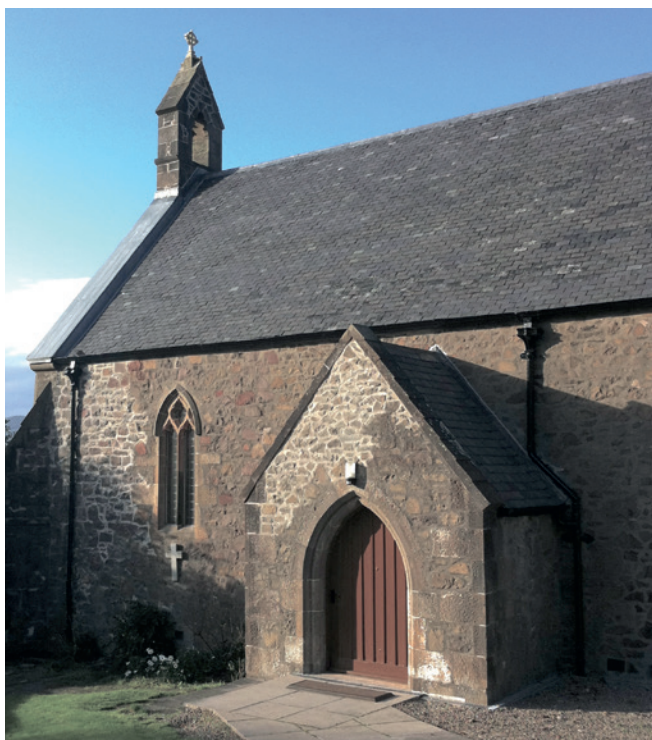
A reslated roof with lead caps to the skews

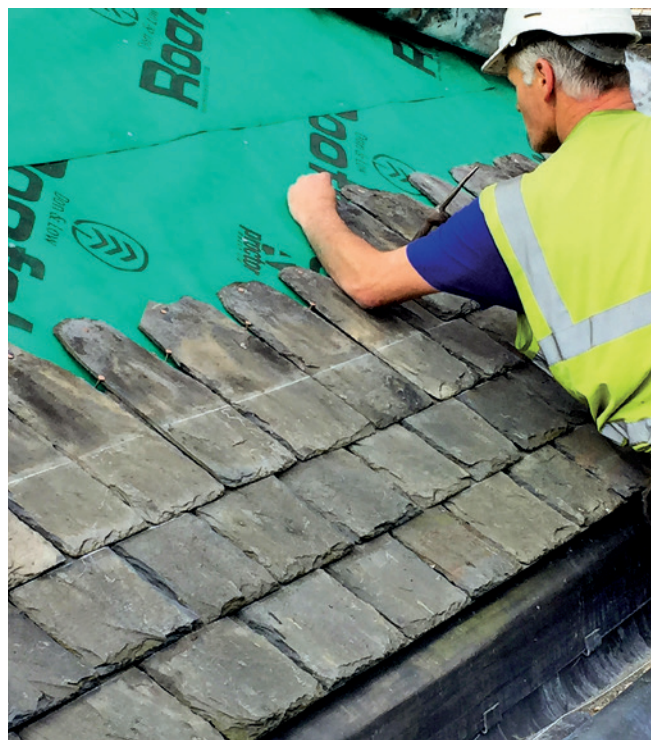
A roofer cheek nailing slates on an exposed roof

Slates disturbed by high winds often rattle on their fixings, which wears away the fixing holes and then loosens them, making them more prone to slippage. The choice of nails and fixing methods can make a significant difference to whether a roof can withstand extreme weather.

The typical specification for Scottish slating is to ensure a good deep lap of slate coursing, and commonly the outer two metre edge of a roof is fixed more securely by double nailing or cheek nailing (a nail at the head and another at the side of each slate). We have seen an extraordinary collection of refixing methods, using 'tingles' (clips) and adhesives as an attempt to keep the slates on, but have found the same roof will remain sound in storm conditions if properly re-slatted with traditional detailing and in accordance with best practice.

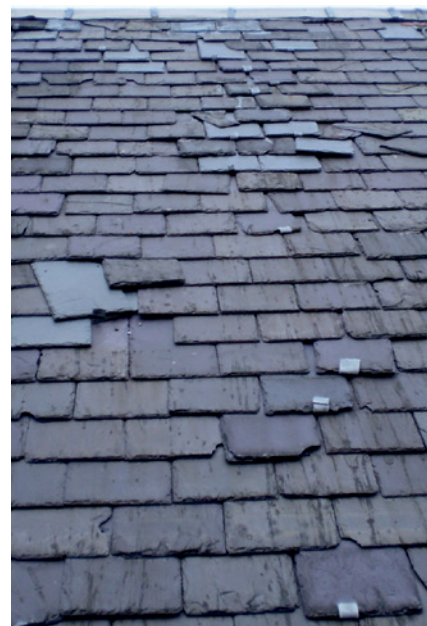
A wind-damaged slate roof with tingles and a variety of other poor repairs

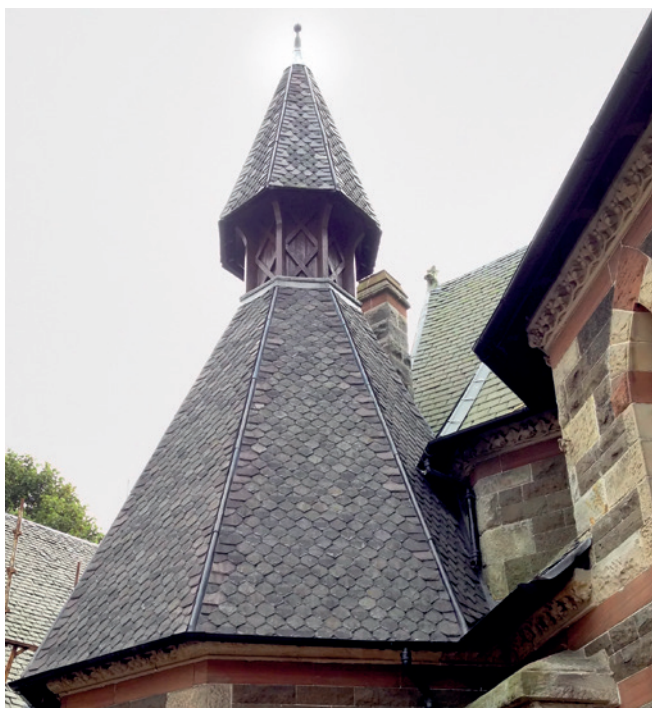
New Welsh slate work on the vestry spire of Trinity, Irvine with code 6 lead roll hip ridges

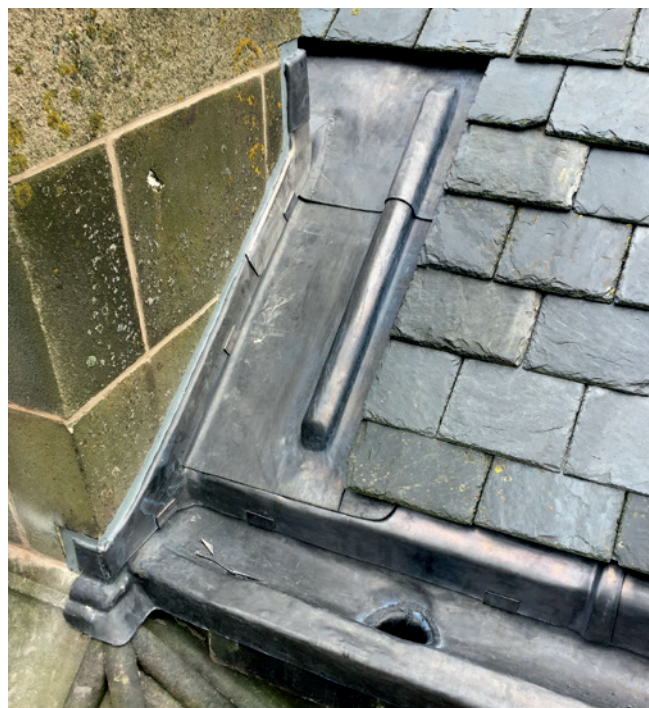
A relined channel gutter with a new watertight detail above

A particular detail of older churches with a classical Georgian design is a lead-lined channel on a parapet. This detail is routinely found to be a problem as the capacity of the channel is incapable of handling the quantity of water now experienced and the stonework is often badly eroded. Capacity may be increased by indenting the channel or by fixing a timber section to the outer edge to increase depth, which can then be dressed in lead. Forming steps in the lead lining of these channel gutters is usually not possible and the use of neoprene gasket jointing strips (such as T-Pren) may be necessary.

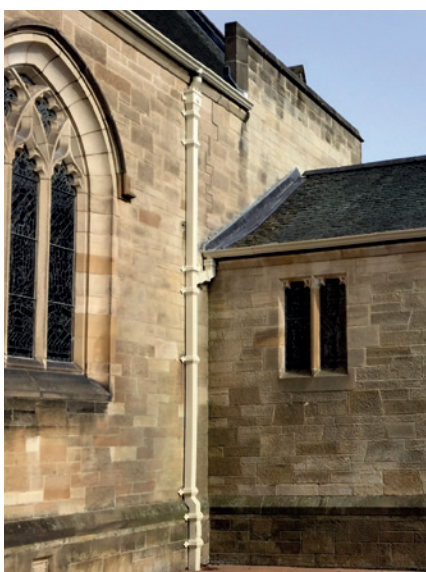
Rainwater goods replaced with larger cast iron sections and a wide watertight detail to cope with increased rainwater

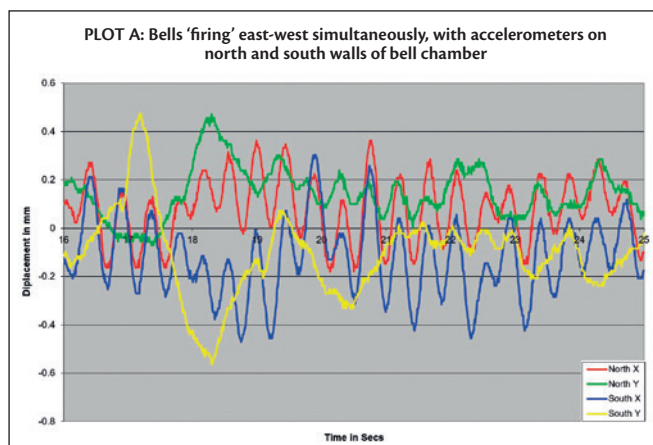
This plot shows the movement in the north and south walls of the bell chamber when all bells oriented east-west (the Y axis) are rung simultaneously, producing a large pulse. The effect on the tower is captured by accelerometers attached to the masonry of the north and south walls of the bell chamber. The pulse leads to a jerk on the east-west axis (yellow and green lines) which is much longer than the natural frequency of the tower which is just over 2Hz.

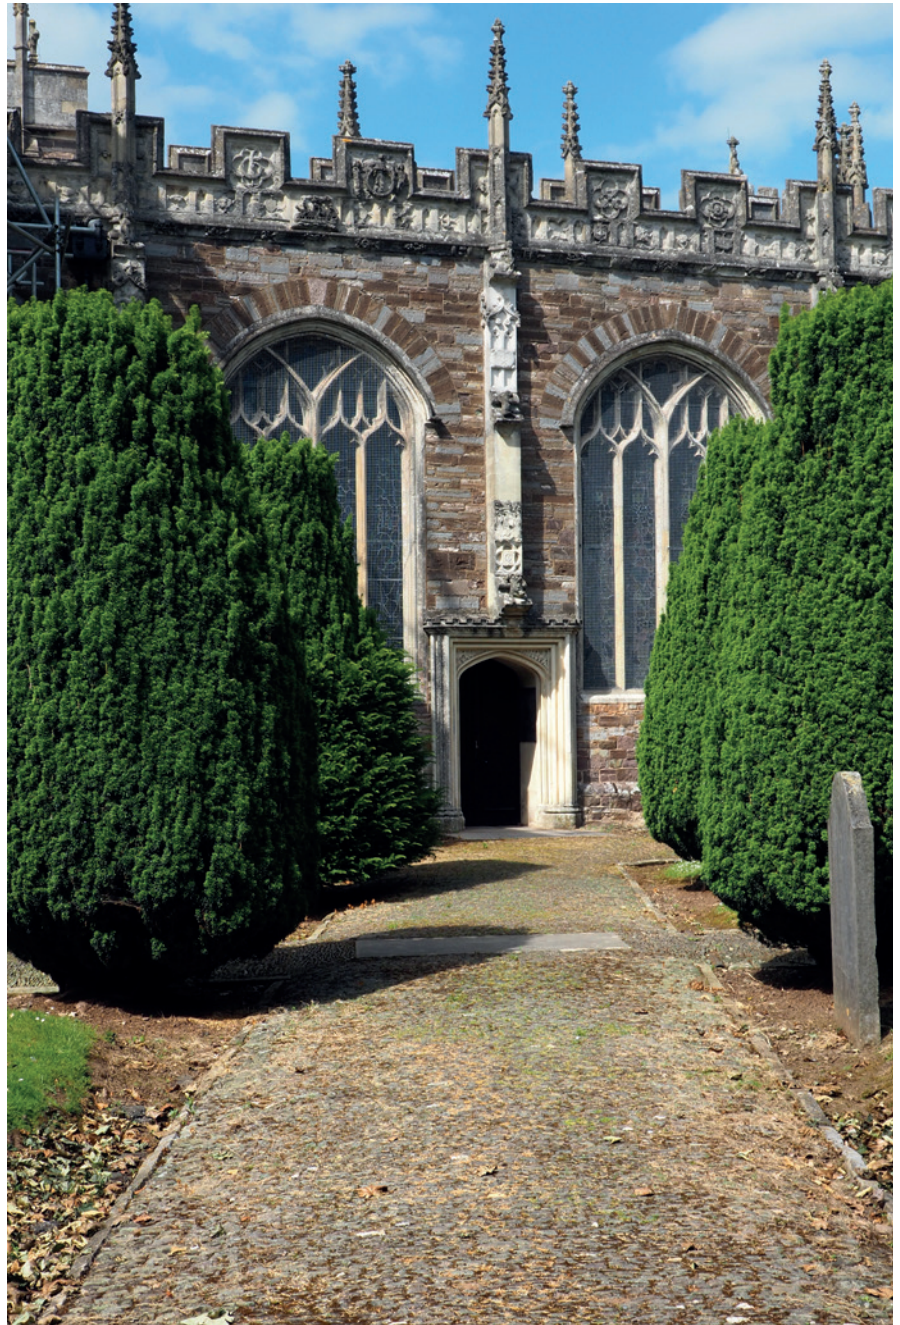
Tightly packed flat-topped cobbles bound by small kerb stones provide a relatively even surface at St Peter's, Tiverton, Devon

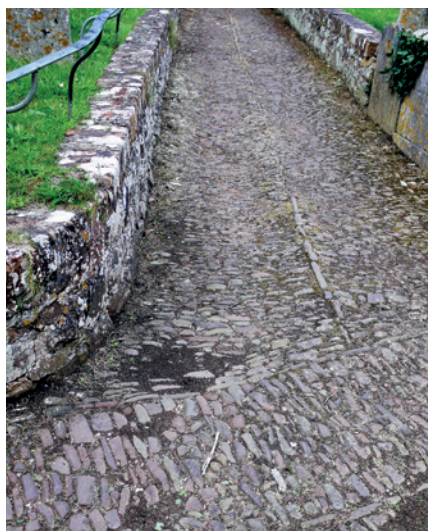
St Swithuns, Sandford, Devon: some areas have sunk and collect water, but otherwise this section is in good repair

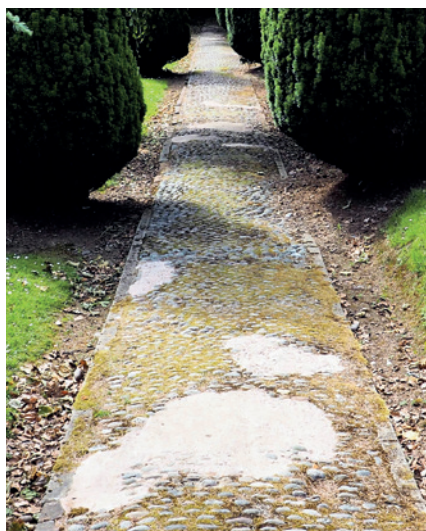
Ugly concrete infill and cement repairs

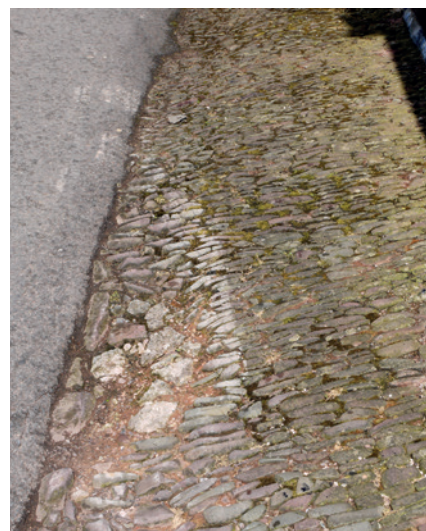
Another inappropriate repair using mismatched stones

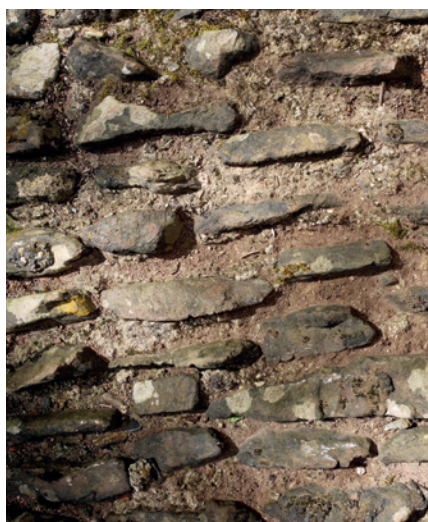
Plants removed from cobble revealing a worn original earth mortar infill

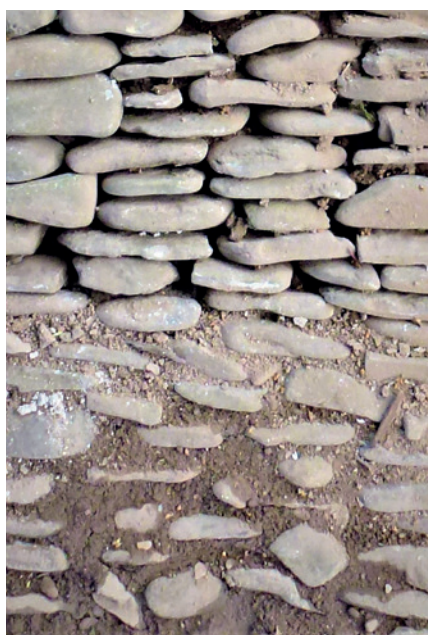
Cobbles partially backfilled with sub-soil, showing the flat-topped form of reclaimed river-worn cobbles

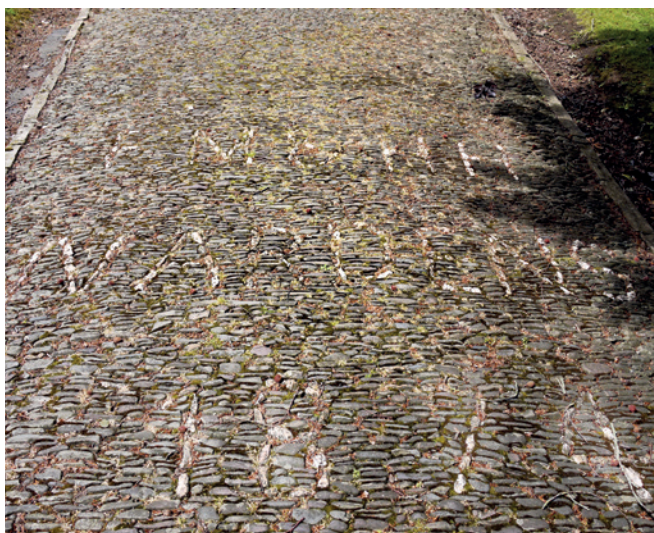
Calcite lettering on a path at St Peter's, Tiverton

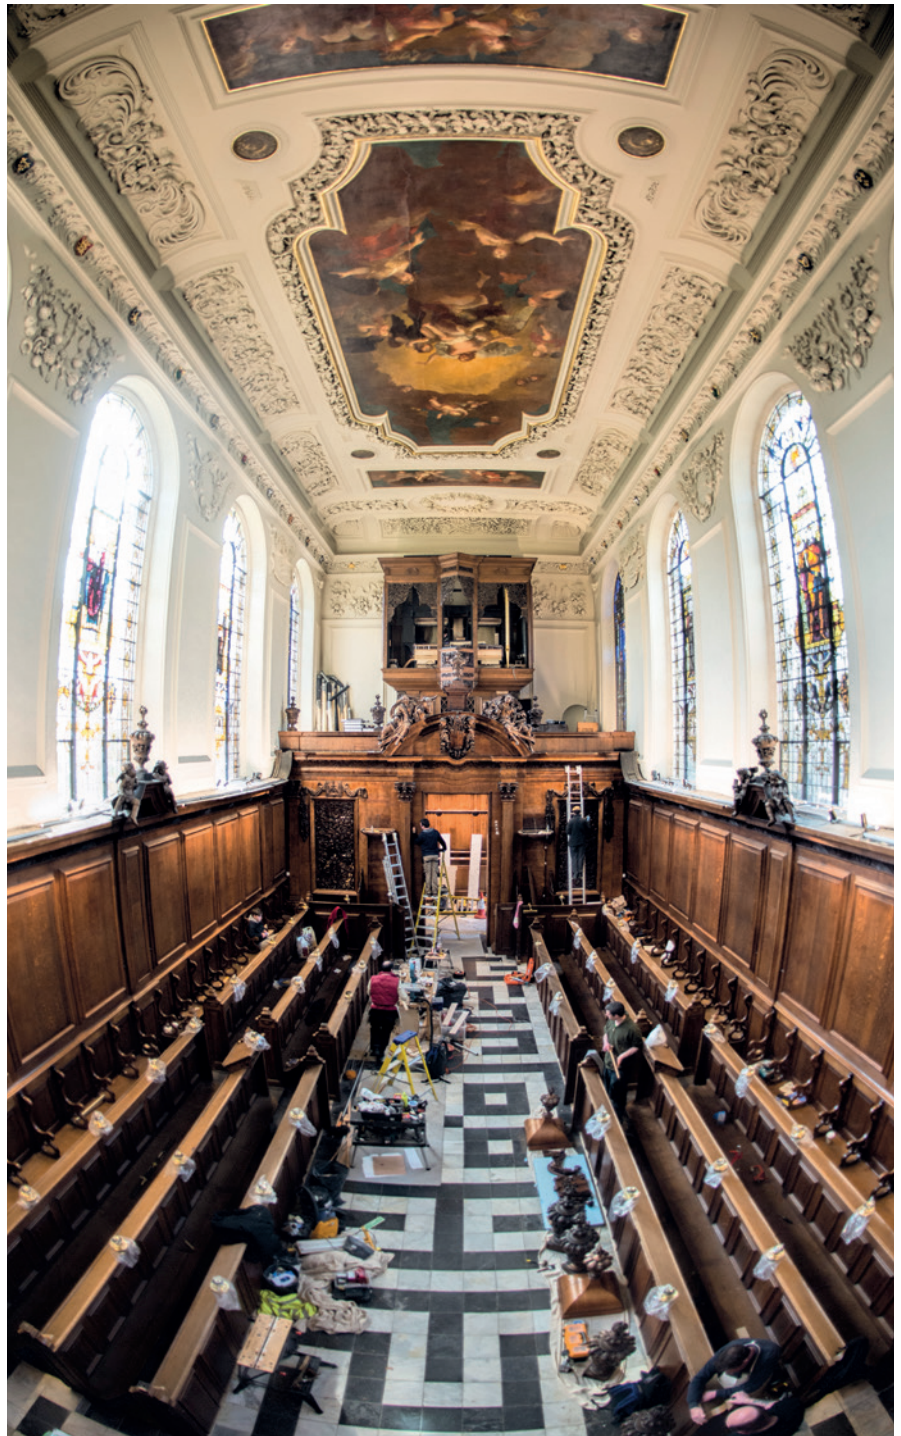
Conservators at work on Grinling Gibbons' screen which divides the antechapel from the nave (All photos: Bruce Hammersley)

On entering the chapel today, the most striking feature is Grinling Gibbons' magnificent screen which divides the antechapel from the nave. It features fluted Corinthian columns and an arched pediment, topped with carvings of the Evangelists, and has two fretwork panels either side, with putti (infant angels) at their centres.
