The
Building
Conservation
Directory

HISTORIC

CHURCHES

THE CONSERVATION AND REPAIR OF ECCLESIASTICAL BUILDINGS

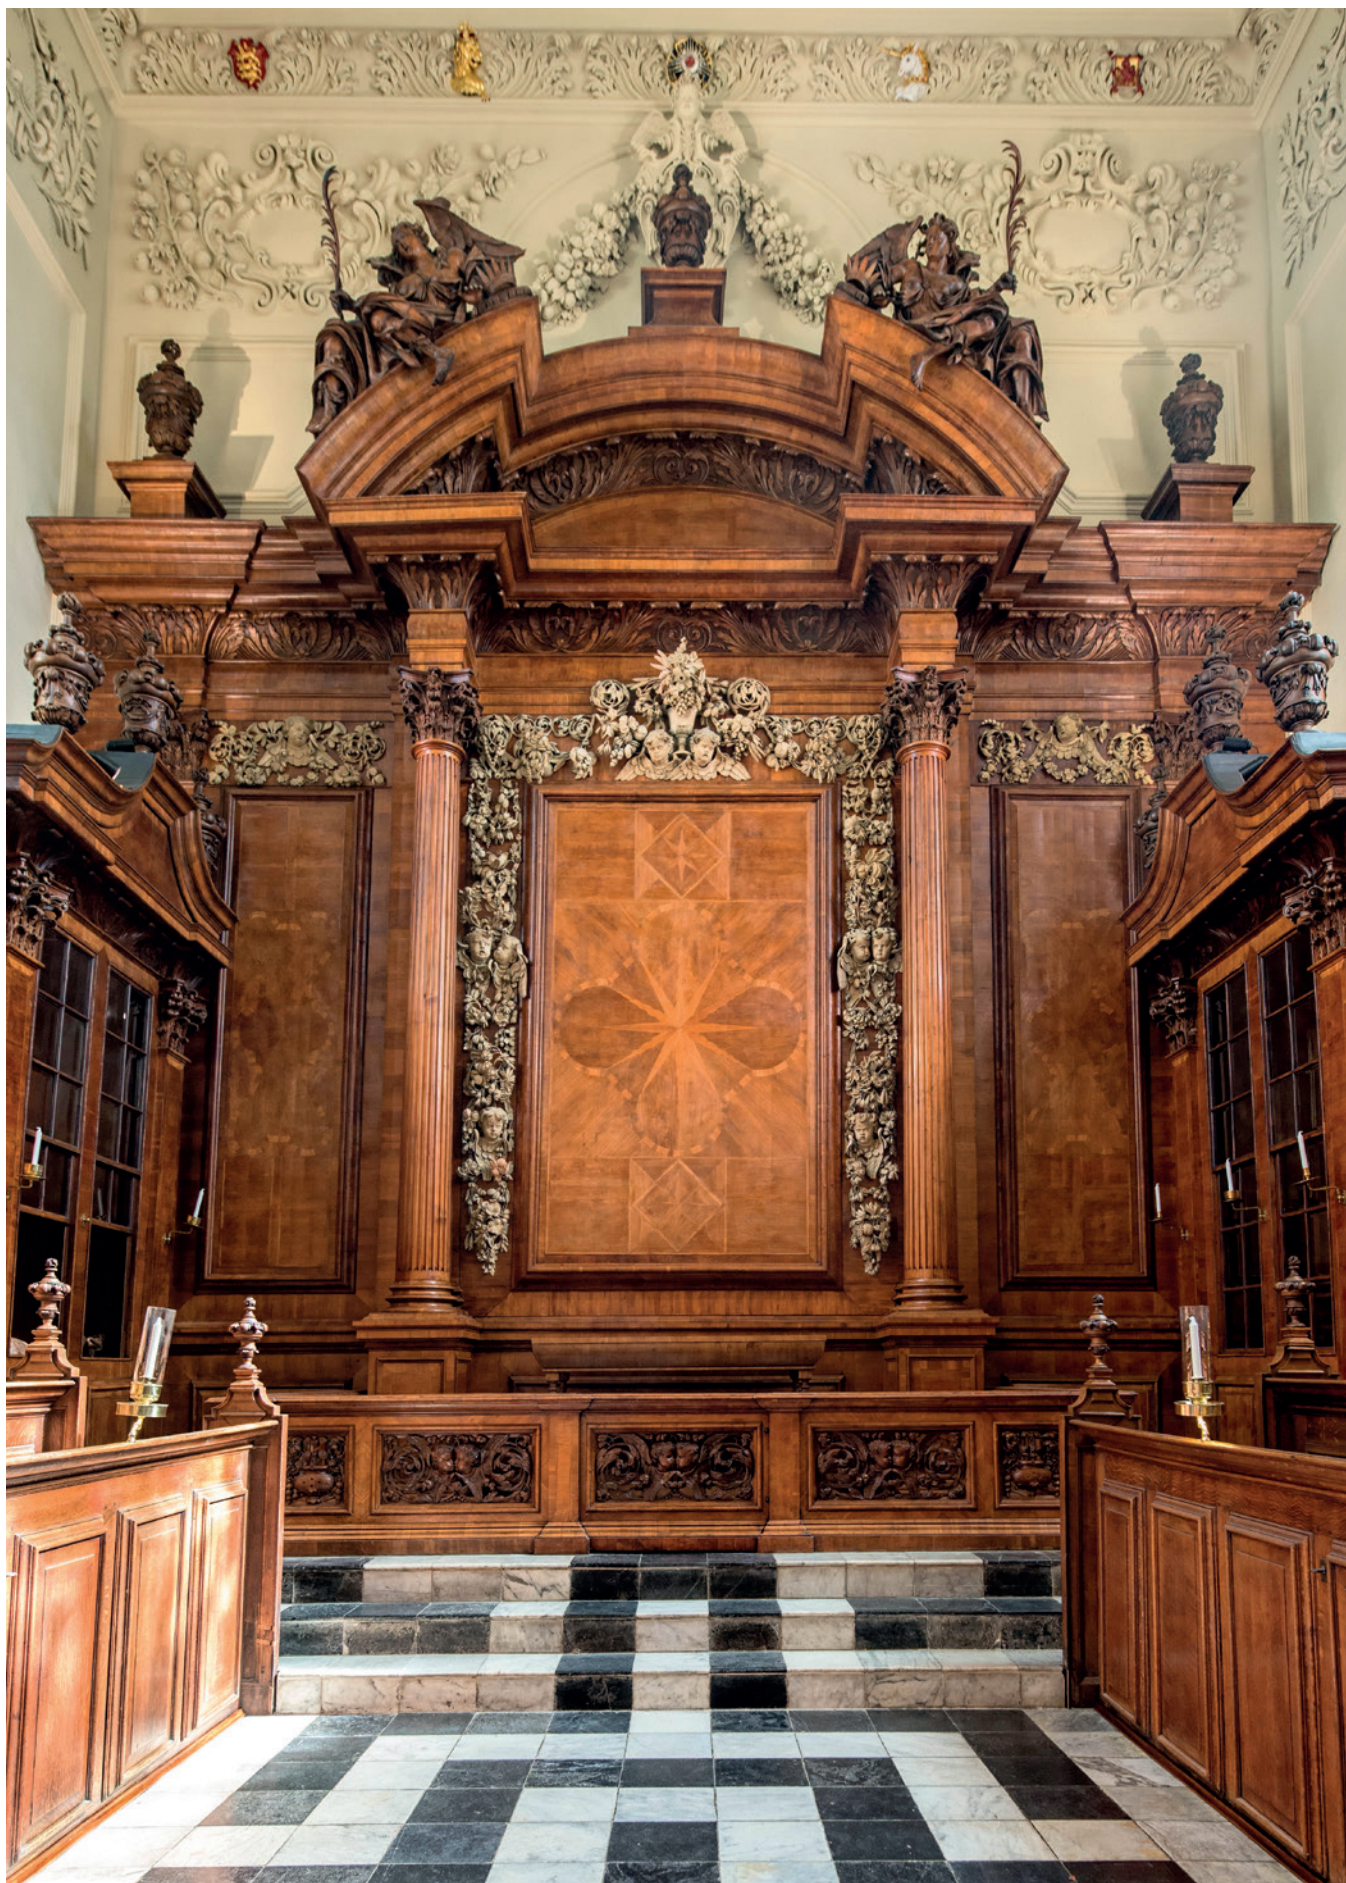
The conserved reredos against the dried out east wall of the chapel

An environmental monitoring survey was carried out by Brian Ridout of Ridout Associates to evaluate the level of damp and relative humidity. The evidence showed that moisture levels in the east wall were excessive, especially at its base. Fortunately for the important woodwork, conditions elsewhere in the chapel were found to be relatively benign.

It was decided to repair and conserve the existing stonework. A lime mortar was used to fill in any voids and a lime mortar

shelter-coat was applied over the surface. At the same time, the ground level was lowered at the foot of the wall and a drainage trench (or 'French drain') filled with free-draining gravel was created to enable it to dry out.

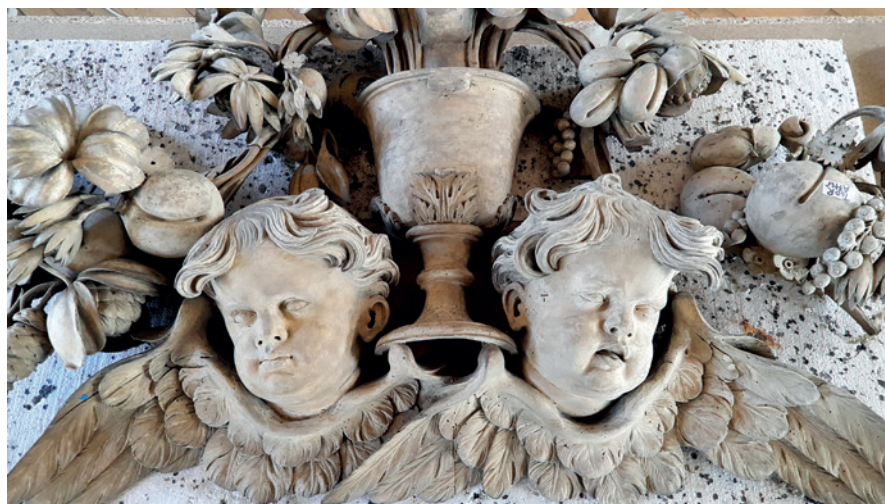
Limewood cherubs and chalice from the head of the reredos during cleaning

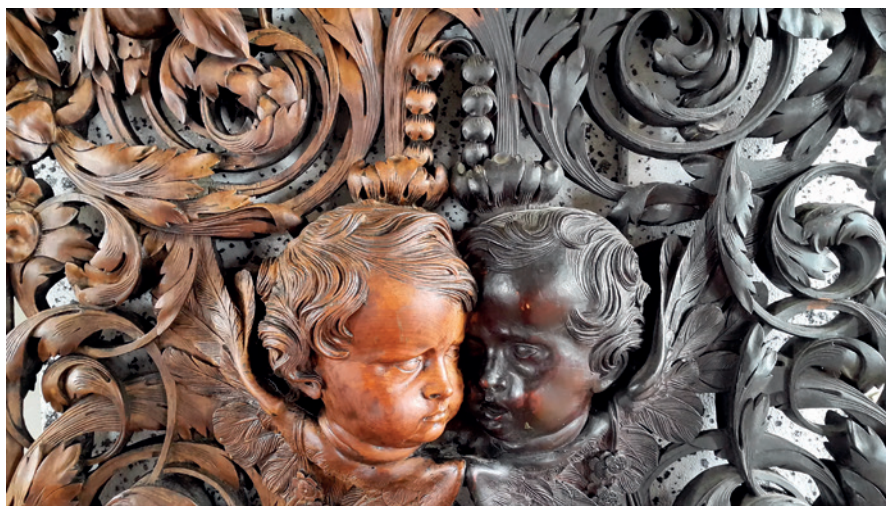
The partially cleaned faces of putti from the antechapel screen: the thick varnish had been applied in the 1860s, obscuring fine detail in the Bermudan cedar carvings

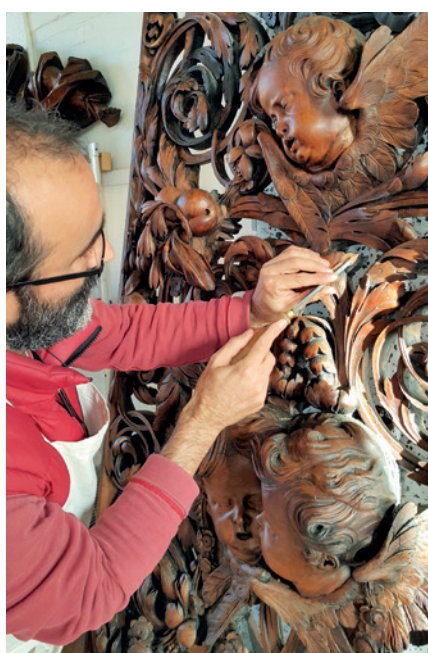
Conservator David Mendieta carving a repair to replace a missing leaf tip

Using mid-19th and early 20th-century photographs, Alan Lamb was able to determine which elements had been lost over time and a number of these were replaced. The decision on what to replace was generally guided by the 'six-foot rule': if it can't easily be seen from six feet away, don't replace it.

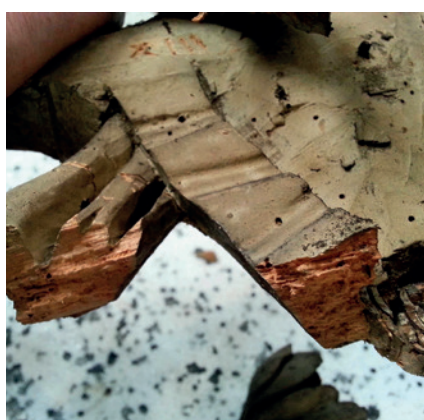
Woodworm damage in carvings of the reredos

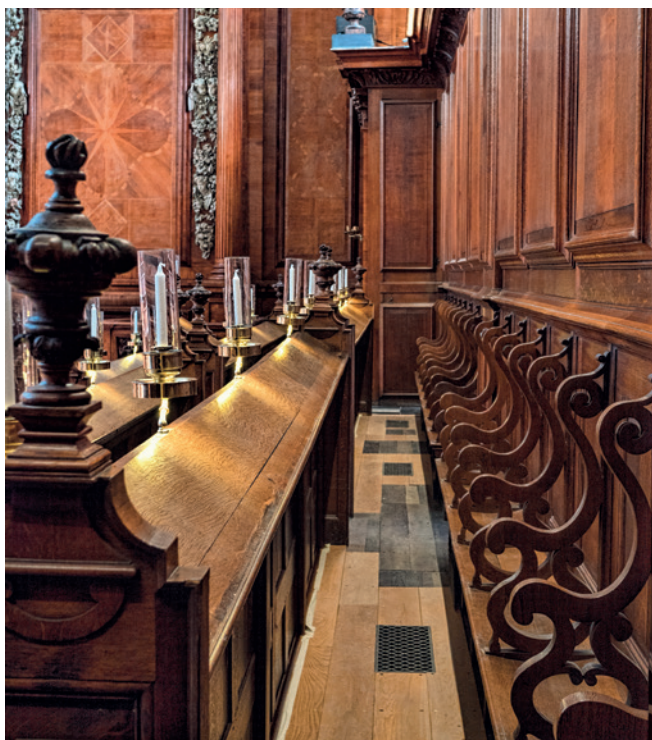
Repairs to the raised floor below the pews, with a mixture of new European oak boards and sections of salvaged originals

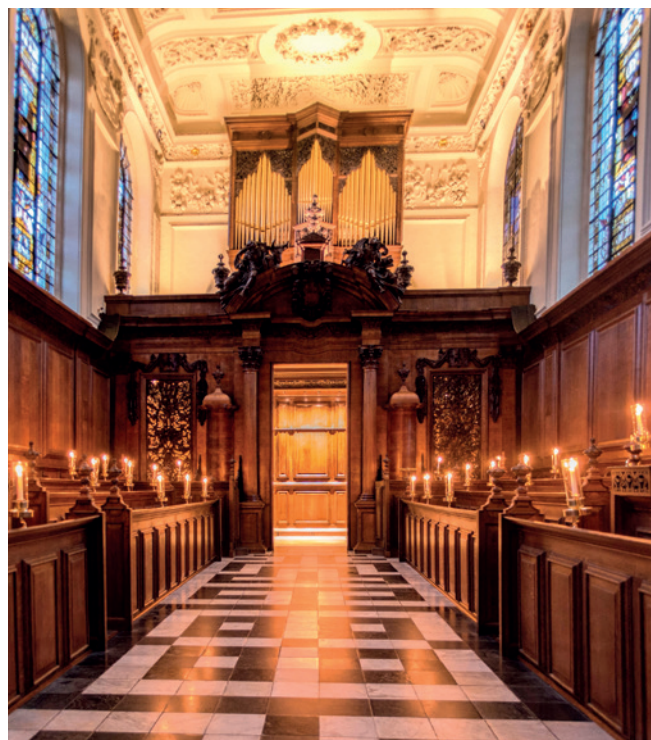
The new lighting scheme: LED light pads beneath the candle holders provide additional lighting during services.

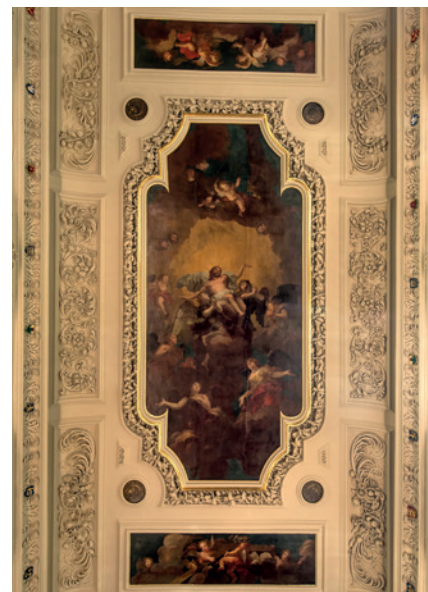
Detail of the ceiling paintings and plasterwork after cleaning and revarnishing

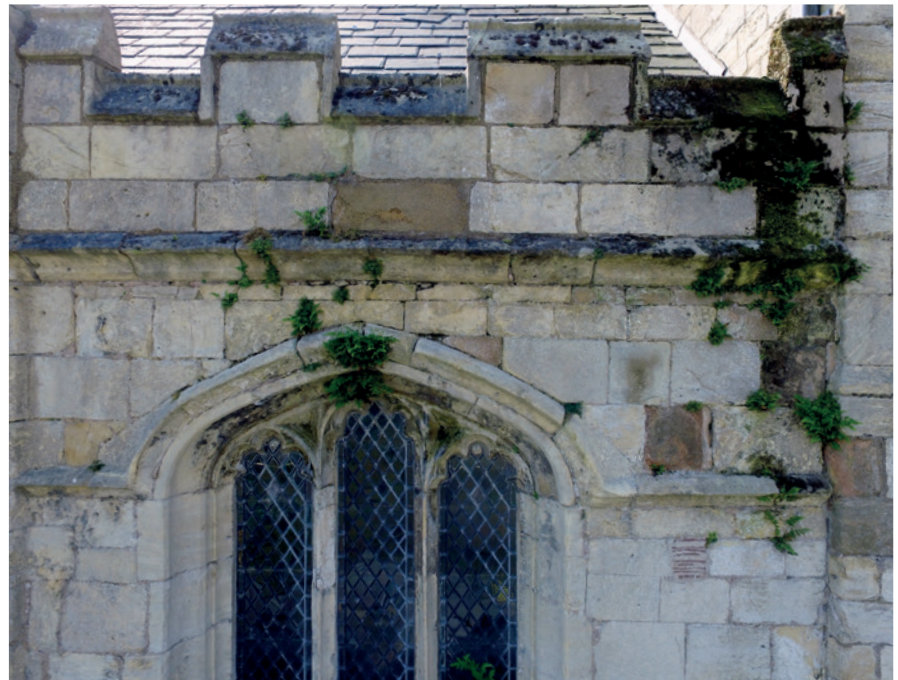
Typical signs of damp caused by an overflowing parapet gutter
